**INDIVIDUAL PROPERTY/DISTRICT
MARYLAND HISTORICAL TRUST
INTERNAL NR-ELIGIBILITY REVIEW FORM**

Property/District Name: Harold G. Bittinger Farm Survey Number: G-IV-A-204

Project: US 219/Oakland Vicinity Improvement Project Agency: MSHA

Maryland Inventory of Historic Properties Form

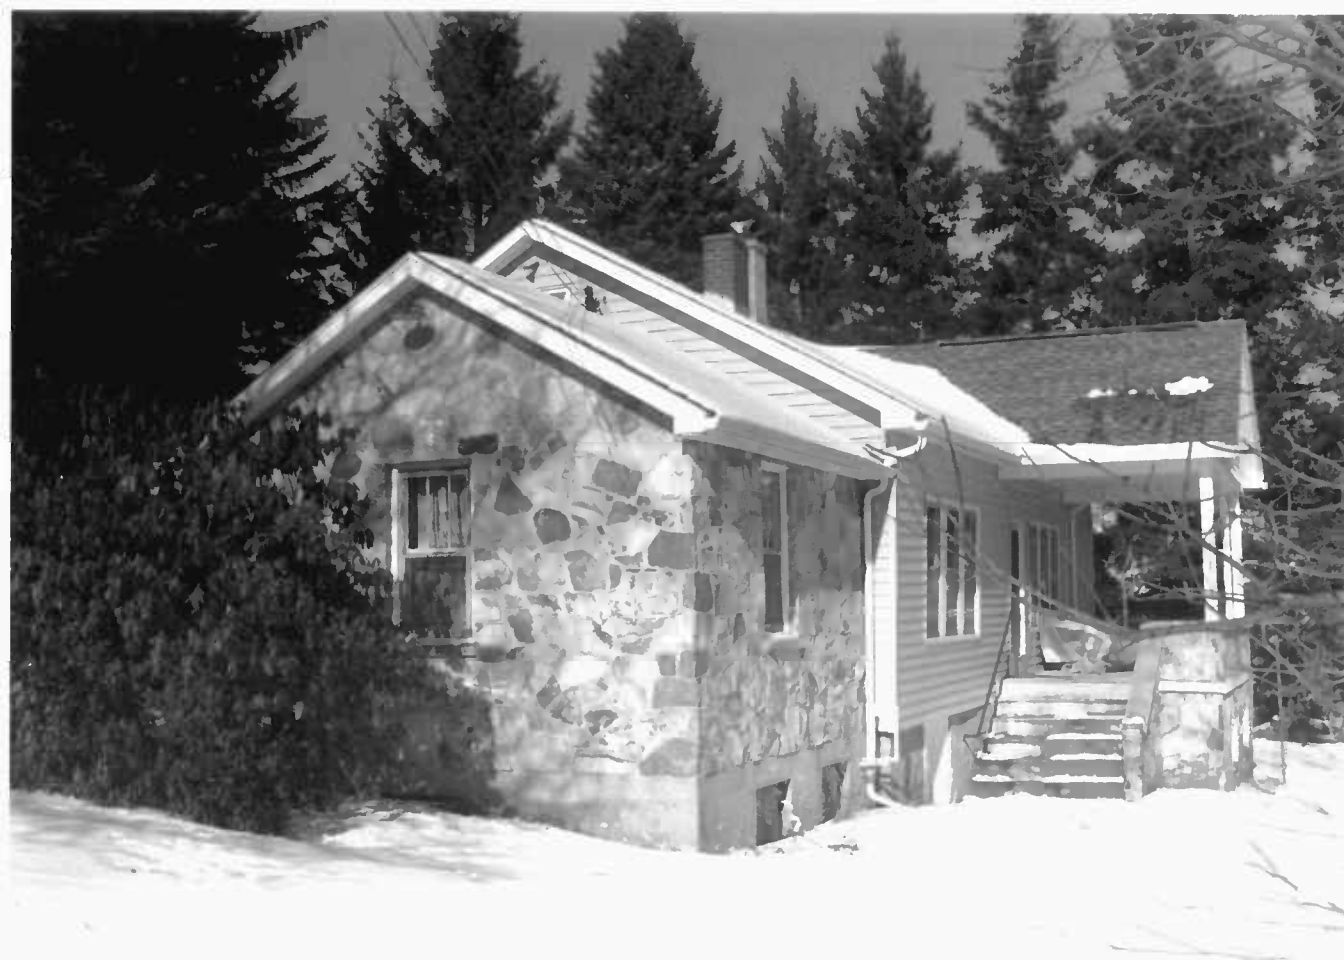
2067

SW + SE ELEVATIONS FACING N

The house is built on a foundation that is a mixture of poured concrete and concrete block. The foundation appears to enclose a full cellar. The walls are clad in gray aluminum siding with white trim, and the building is topped with an asphalt-shingled gable roof finished with an aluminum eave. The addition that extends from the southwest gable is faced with stone, as is the base of the front porch. Two side-by-side interior corbeled brick chimneys rise from the roof at the ridge line.

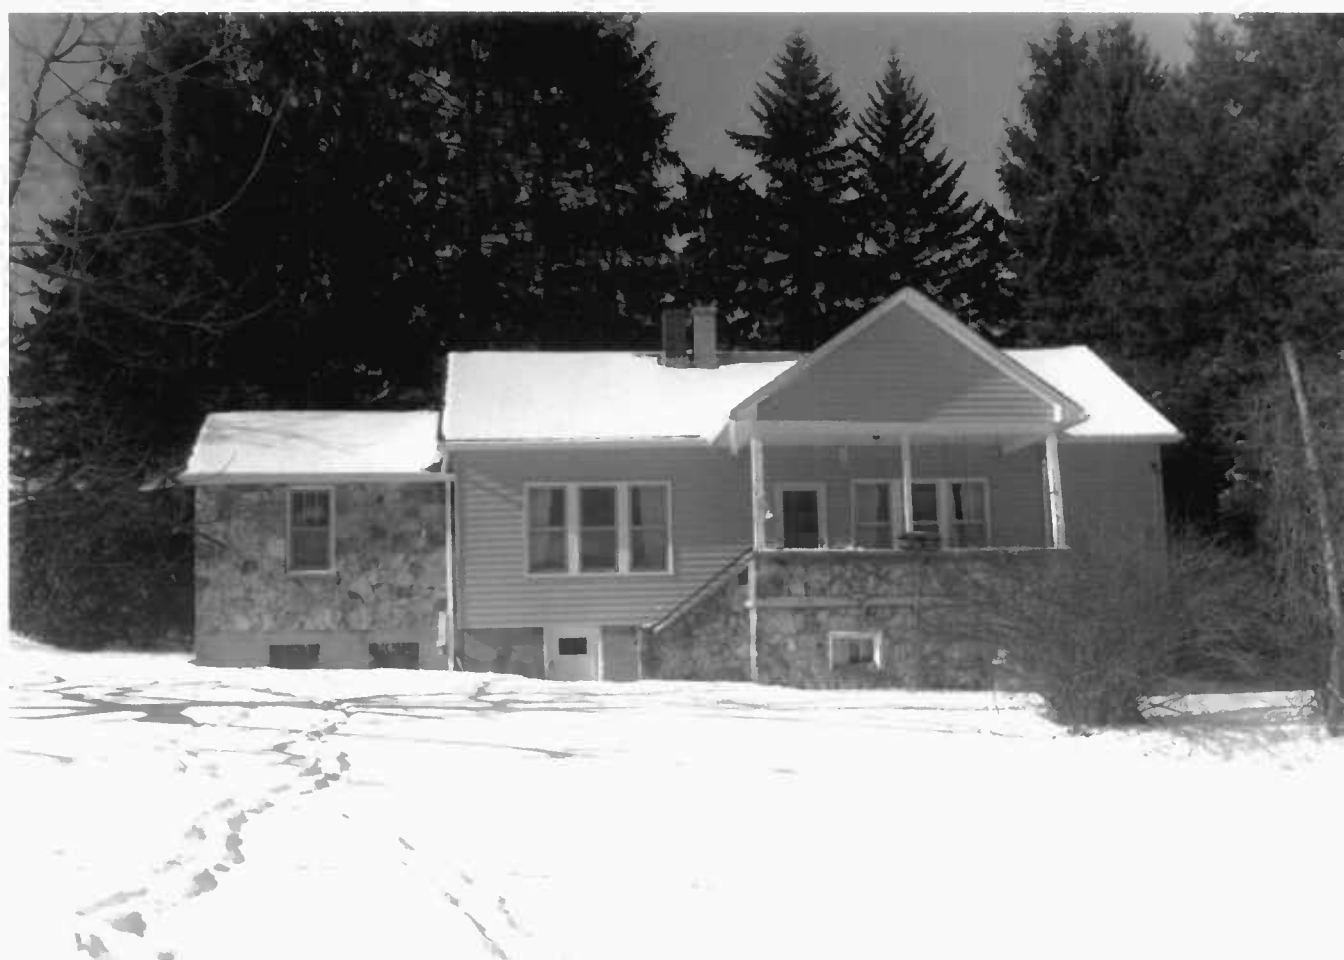
3067

SE ELEVATION FACING W

Several three-light fixed sash windows pierce the front porch at cellar level. All window openings are finished with aluminum surrounds. The front entrance is more or less centered on the southeast elevation. It contains a paneled wooden half-glass door. The cellar door is located on the same elevation and consists of a solid wooden door pierced by a single glass pane on top. Two other entrances lead into the northeast and southwest sides of the rear addition. All door openings are finished with aluminum surrounds.

The open-sided front porch consists of a stone-faced foundation, four-by-four wooden posts, a concrete deck, an aluminum ceiling, and an asphalt-shingled gable roof. The porch gable is clad in aluminum siding to match the rest of the house. Concrete steps bordered by a stone-faced railing lead from the yard up to the level of the porch deck.

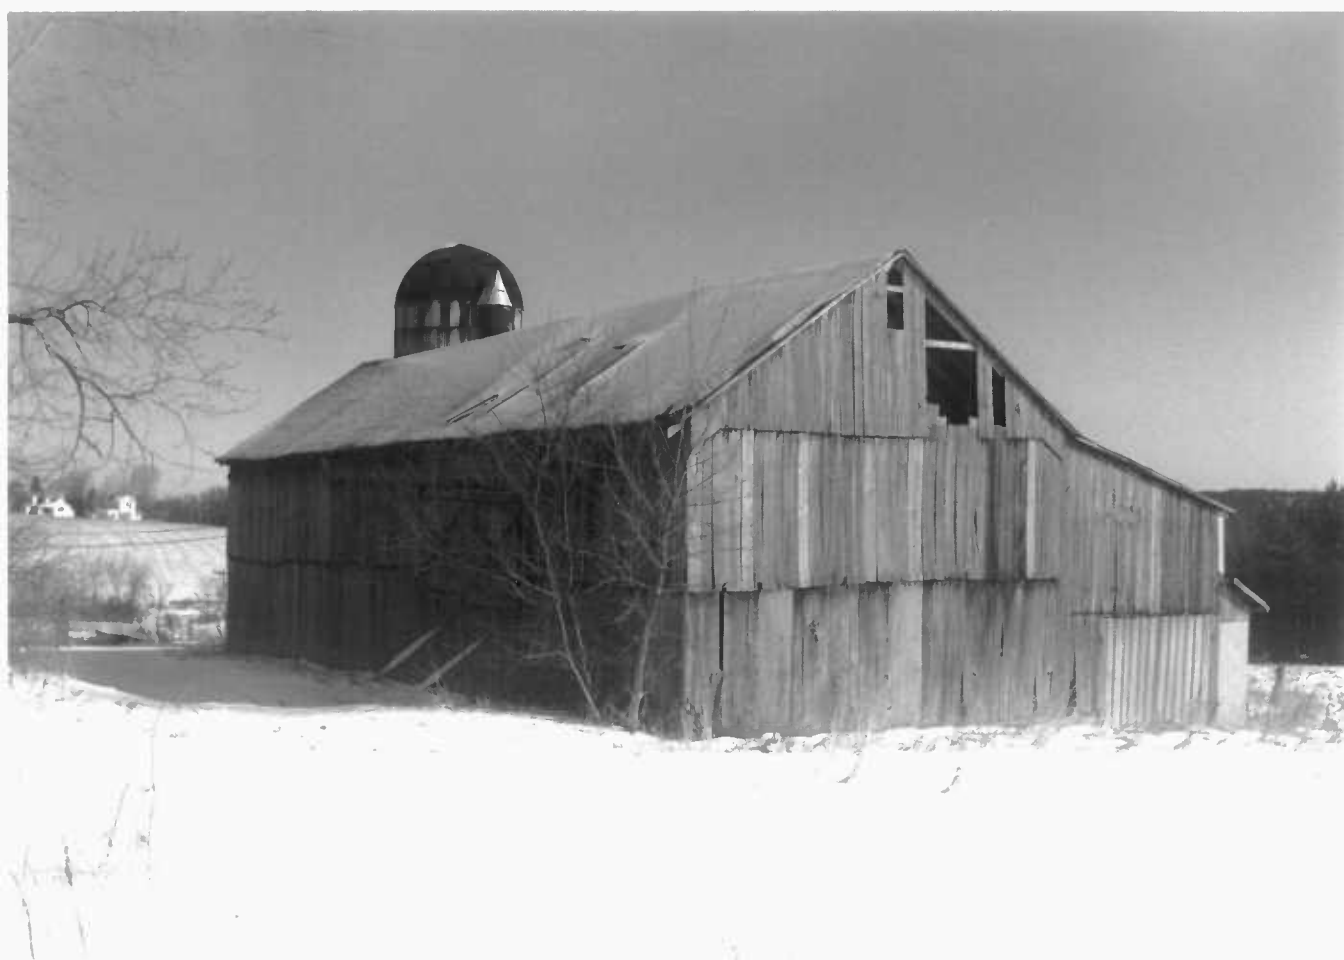
4 of 7

NW + SW ELEVATIONS FACING E BARN

Several outbuildings stand on the property. A one-story gable-roofed cinderblock shed topped with an asphalt-shingled roof stands just to the south of the main house. This building is accessed by a five-panel wooden door and lit by six-light fixed sash windows; all door and window openings are finished with wooden surrounds. A one-story gable-roofed frame dwelling stands just behind and to the west of the main house. This building is constructed on a concrete block foundation, sheathed in asbestos shingles, and topped with an asphalt-shingled roof. An exterior metal stovepipe exits from the building through the foundation. A paneled wooden door provides access to the interior. Windows are mostly two-over-two, double-hung sash. A shed-roofed frame shed stands to the south. This shed stands on a concrete block foundation; it is clad in a mixture of vertical wooden boards and corrugated metal on one long wall. The building is pierced by sliding wood and metal garage doors and several two-light sash windows. A two-story gable-roofed concrete block garage is located south of the house. This building is topped with a corrugated metal roof finished with exposed rafter feet; the tops of the gables are clad in board-and-batten siding. Two sliding wooden garage doors open into the northeast gable of this building, and several two-light fixed sash windows light the interior. A vertical board door at second-floor level opens into the southeast elevation; a metal stovepipe exits from the center of the building near the ridge line. A long and narrow one-story frame wooden-floored corncrib topped with a corrugated metal roof stands just south of the garage. This building rests on concrete block piers and is sheathed in open wooden slats for ventilation. A one-story frame shed stands behind the corn crib to the southwest. Constructed on brick piers, this building is clad in wooden shingles and topped with a rolled asphalt shed roof. Several six-over-six, double-hung wooden sash windows light the interior. A ruinous bow-roofed, gable-fronted frame shed or chicken coop stands behind the corn crib and the first shed. This building rests on stone piers; it is clad and roofed in rolled asphalt. A wooden door pierces one gable. The building is finished on the interior with a wooden floor. A long gable-roofed frame barn with a full-length concrete-block shed roofed addition on its southern elevation stands south of this cluster of smaller buildings. This barn is sheathed with vertical wooden boards and topped with a rolled asphalt roof. A large set of swinging wooden doors opens into the long northern elevation, and a one-story gable-roofed concrete block addition projects from the southwest corner. The principal framing members consist of mixture of hewn and sawn timbers.

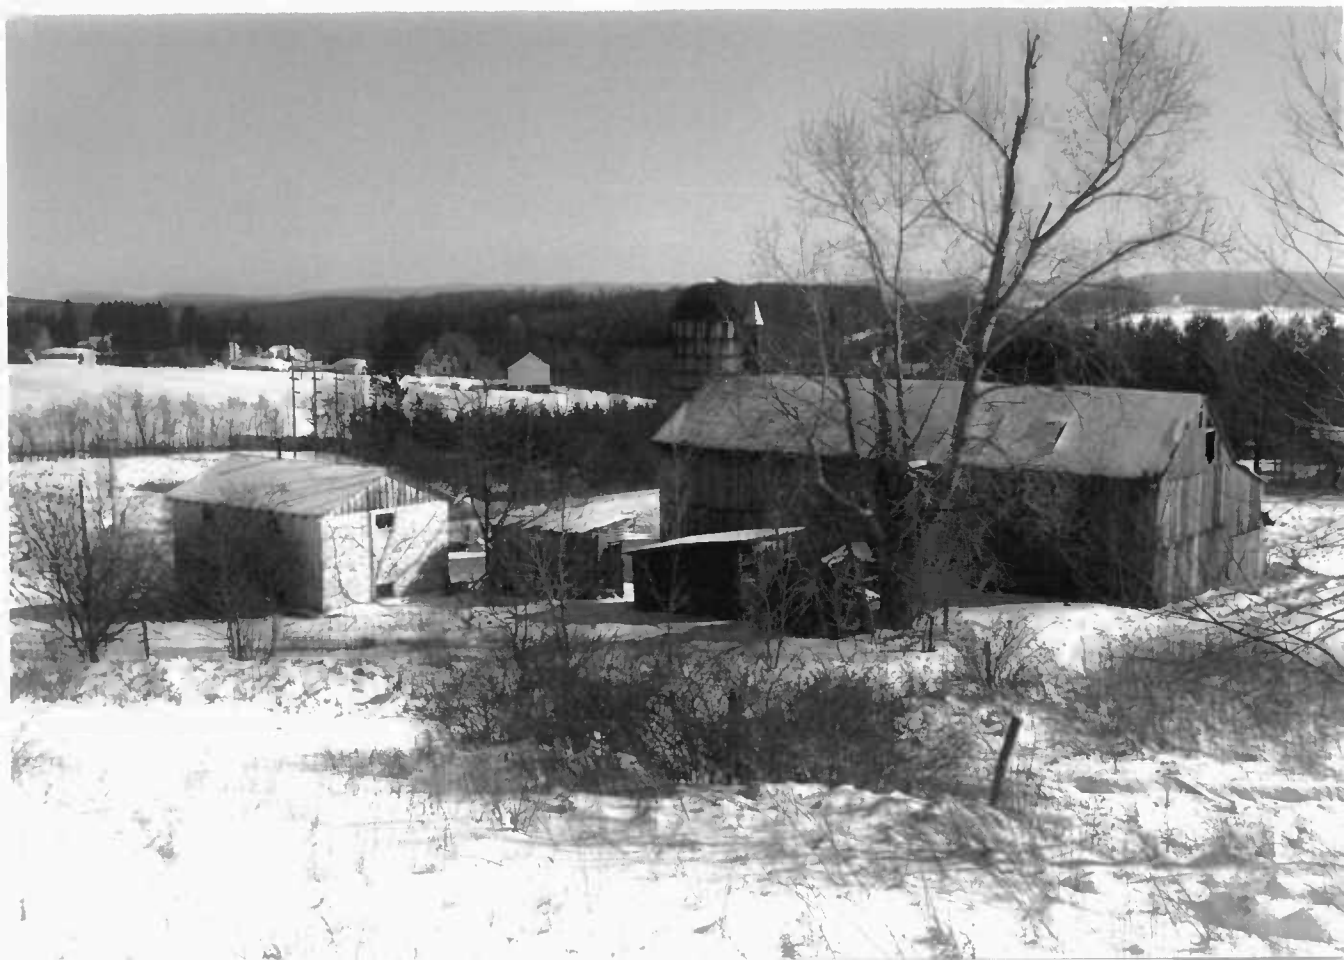
5067

MIN SHPO
WW+SW ELEVATIONS FACING E OUTBUILDINGS

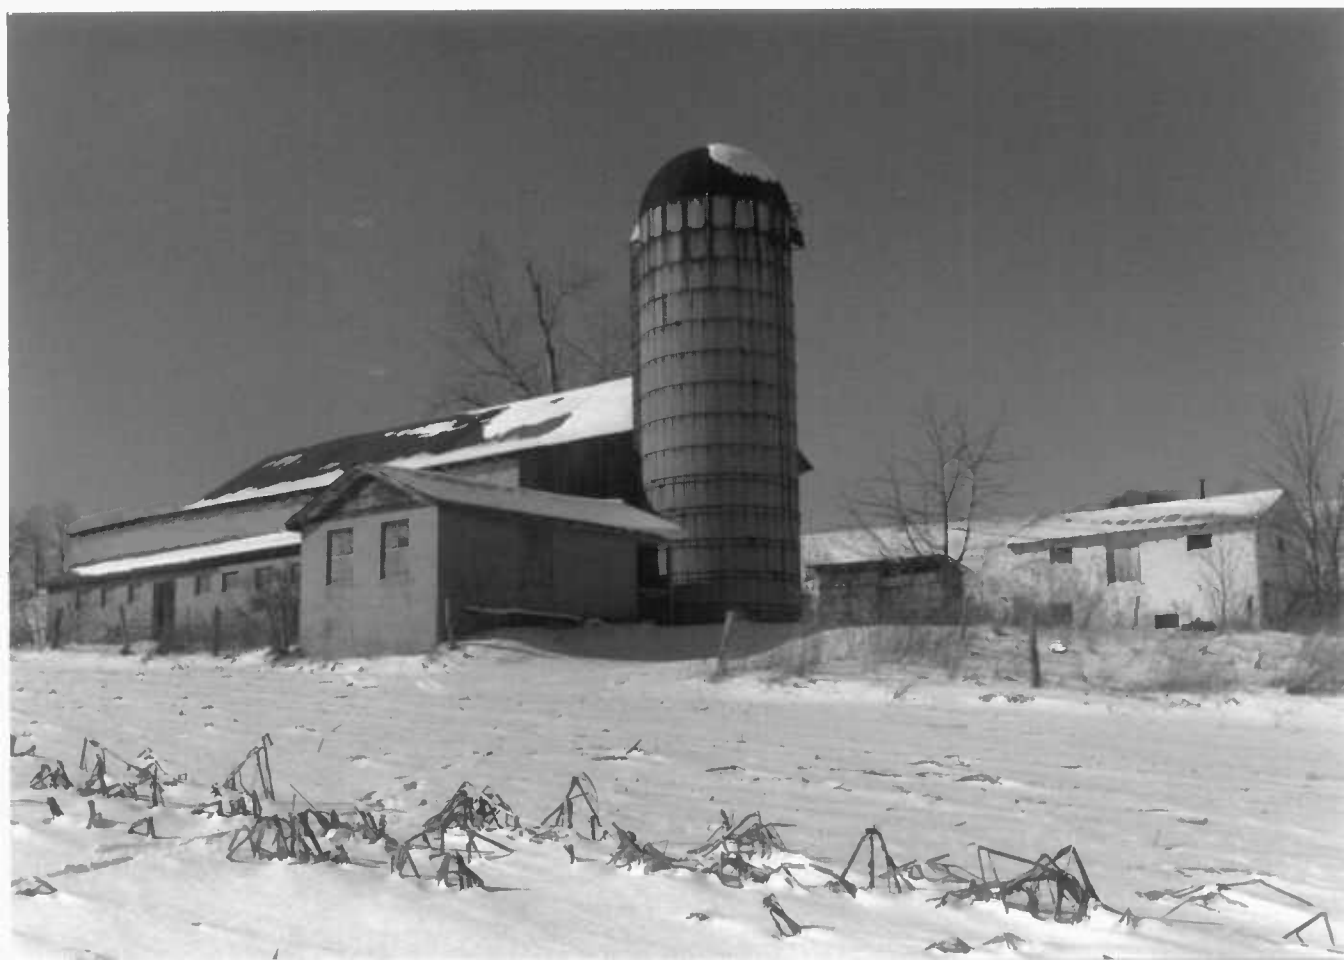
6067

SE+NE ELEVATIONS FACING W

DAIRY/BARN/CORN CRIB/SHED

A concrete silo with a domed metal roof and metal turnbuckles stands to the northeast; a concrete walkway links the silo to the barn. Adjacent to the silo and the southeast corner of the barn stands a concrete block gable-fronted dairy. This building is topped with a gable roof and lit by two-over-two, double-hung sash windows. Horizontal wooden boards sheath the upper parts of the gable walls. An open covered porch supported on four-by-four wooden posts extends from one gable.

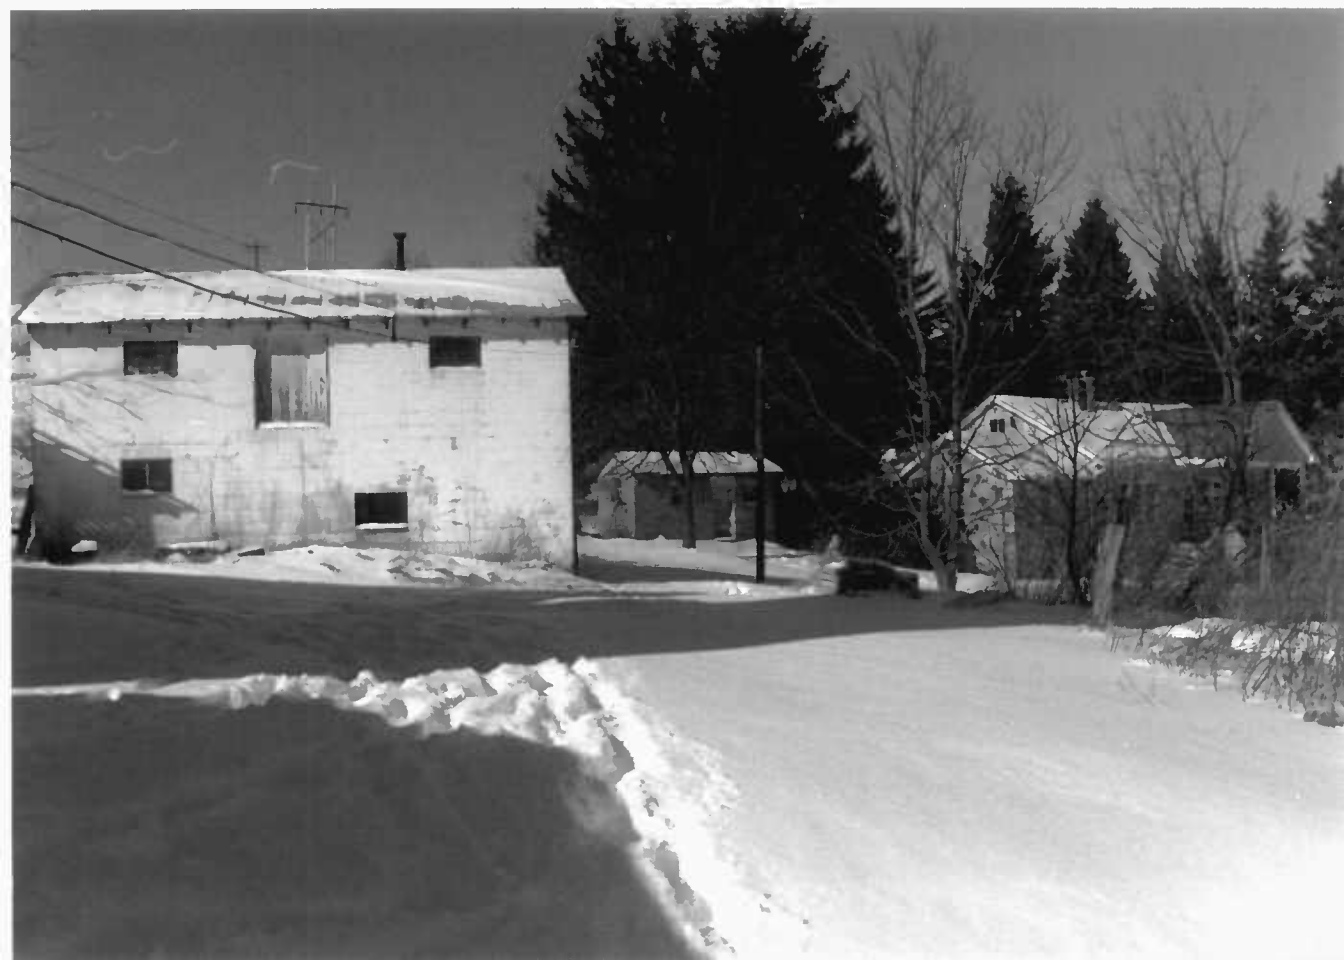
7 of 7

SE ELEVATIONS FACING N 2 SHEDS + HOUSE
